Bloom Park PH 2
 BL / 101 / PH2 Sketch Design
 Scale: NTS
 09.06.2016 lh

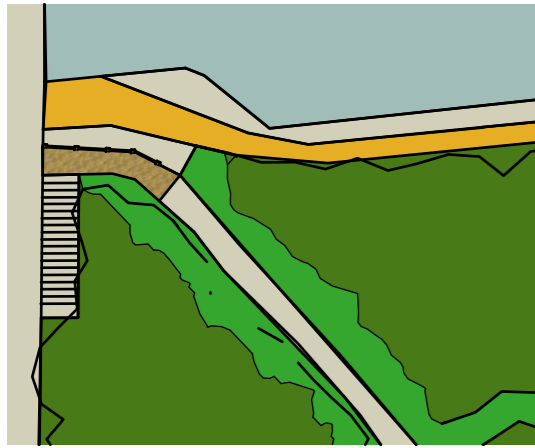
1. Upgrade entrance by refurbishing guard rail as per detail BL.302. (paint + timber posts) & install tegula paving. Remove damaged knee rail.

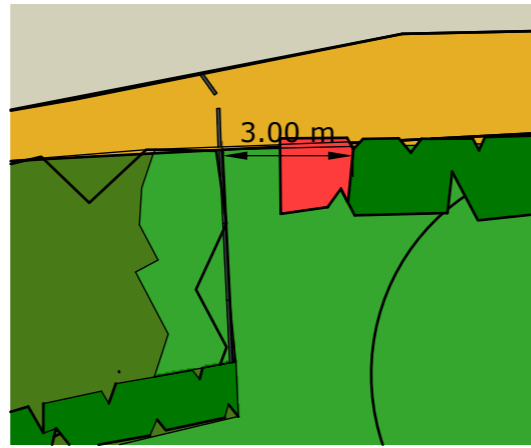
2. Clear 3m section of hedge and self-set trees, level access from towpath. Clear away overgrown vegetation to rear of railings around plantation, clean up and paint railings and gate.

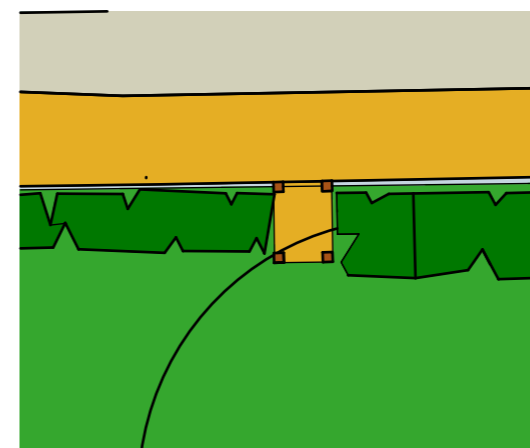
3. Cut back hedge to form 1.2m wide entrance. Install timber edging and gravel and timber posts to mark position of entrance.

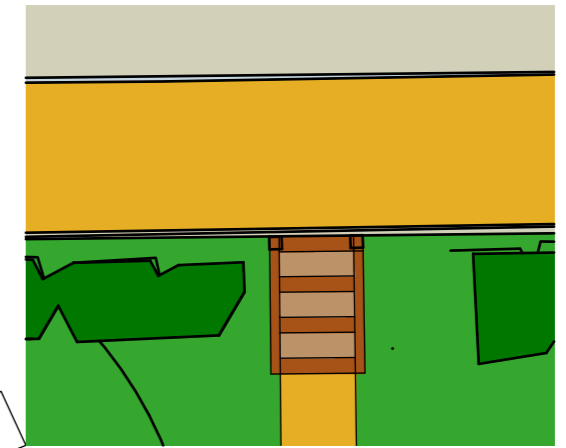
4. Install 4 x timber sleeper and gravel steps and form 1.2m wide path to link with existing hard standing.
